Manhole Inspection Summary

Manhole # S49M__037MH

Insp Date: **2/11/09 11:57 AM**

Location Address: **823 S MILTON-ROSE-ALLEY**

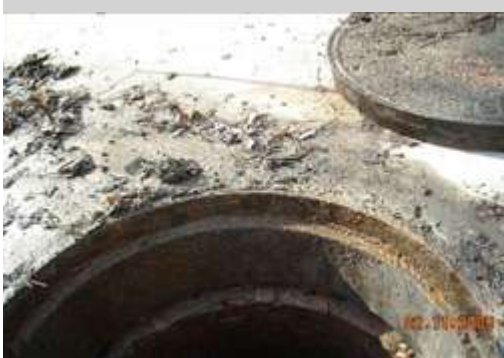
MISC.

Subject To Ponding: **Ponding**

INFLOW EVIDENCE FROM PONDING

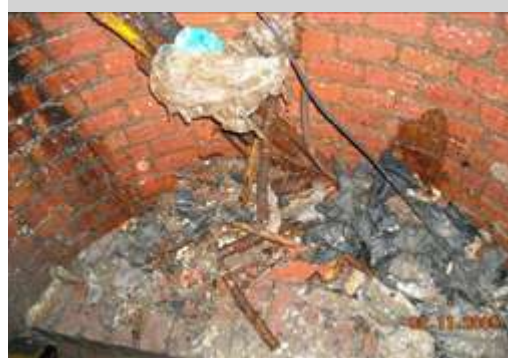
Defect 6

Condition: ☐ Sound ☐ Cracked ☐ Root Intrusion ☐ Deteriorated ☐ Leaks ☒ **Debris**

DEBRIS ON BENCH

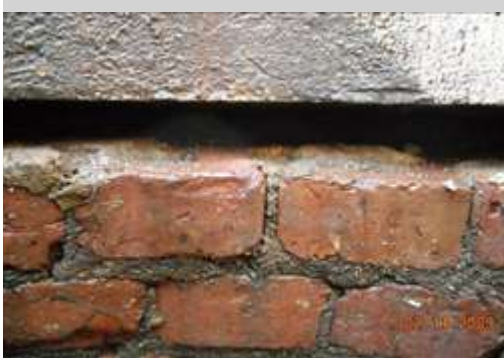
Defect 5

☒ **Leaks**

FRAME LEAKS

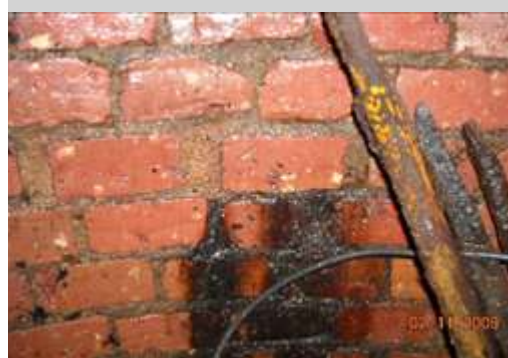
Defect 4

Infiltration: ☐ None ☐ Joint ☐ Cracks ☐ Mortar ☐ Roots ☒ **Wall**

INFILTRATION @ BARREL WALL

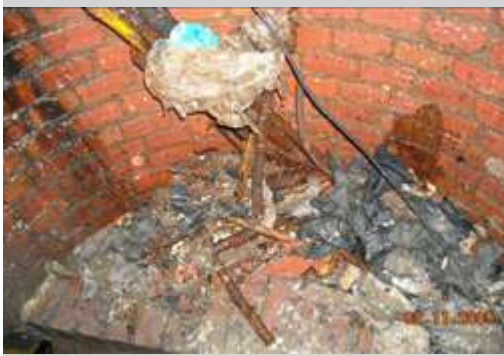
Defect 3

Surcharge ☒ **Evidence Of Surcharge** Depth: **4** (ft.) ☐ Active Surcharge Present

EVIDENCE OF SURCHARGE

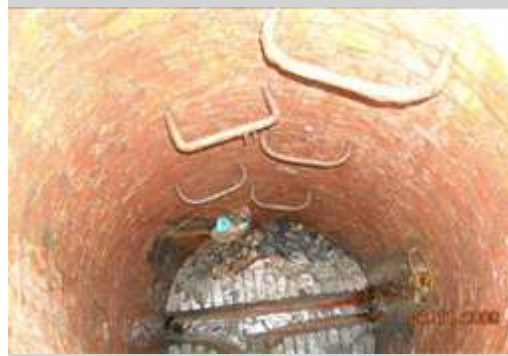
Defect 2

Steps Count: **6** Missing: **0** ☒ **Corroded**

CORRODED STEPS

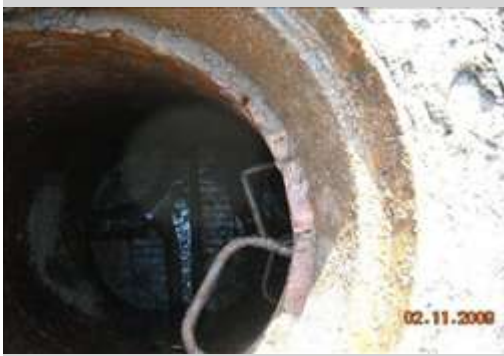
Defect 1

Frame Offset: **1** (in.)

FRAME OFFSET

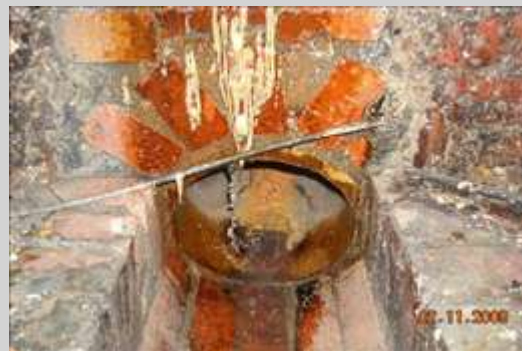
Drop In @ 6 O'Clock

Drop: **Outside** Rod and Bar
Angled: **Yes** Reading: **9.74** (ft.)
Inv Depth: **10.74** (ft.)
Drop Condition: **Partly Clogged**
